SECTION 22
CONNECTICUT COASTAL STRUCTURES INVENTORY STUDY

PHASE I - NEW LONDON COUNTY

APPENDIX A
WATCH HILL QUADRANGLE
RECORDS OF STRUCTURES WITH PHOTOGRAPHS

DEPARTMENT OF THE ARMY
NEW ENGLAND DIVISION, CORPS OF ENGINEERS
WALTHAM, MASSACHUSETTS

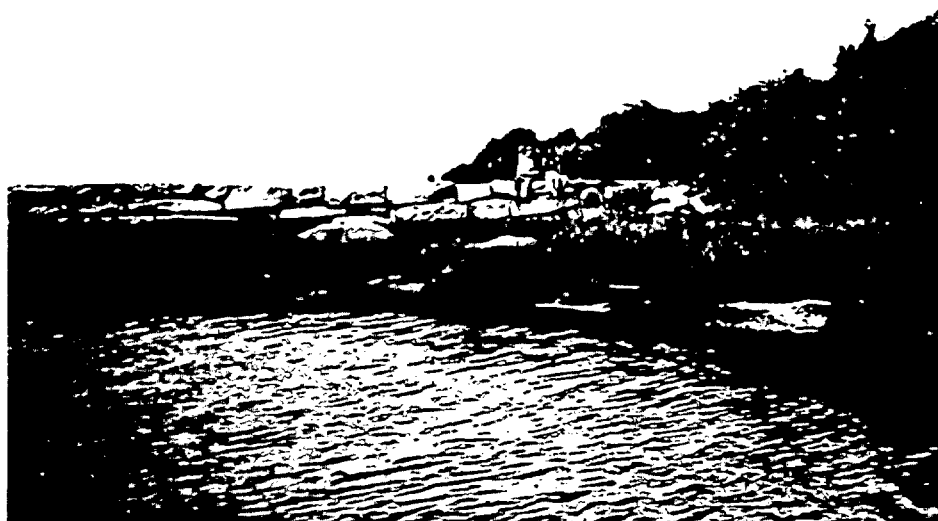
WH 1.00 #1

STONE BULKHEAD WITH WOODPIER SUPPORTED BY 14 PILES
APROX. L= 105 FT, W= 10 FT, HEIGHT ABOVE MHW= 4 FT

#1 ROLL 1 NEG 1 BULKHEAD
#2 ROLL 1 NEG 2 PIER
#3 ROLL 1 NEG 3 BULKHEAD AND PIER
#4
#5

STRUCTURE NOT PROTECTING HOME OR COVE NOT INTENDED FOR
COASTAL EROSION CONTROL. SHORELINE TO EITHER SIDE OF
STRUCTURE LINED WITH BOLDERS.

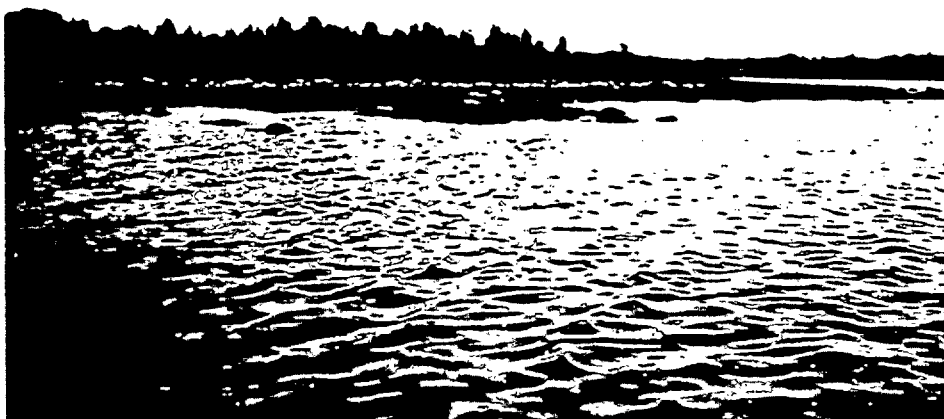
WH 2.00 #1

ROCK GROIN AND RIPRAP SHORELINE
APROX. L=180 FT, W=60 FT

#1 ROLL 1 NEG 4 ROCKS LINING SHORE EAST OF GROIN
#2 ROLL 1 NEG 5 STRUCTURE FROM POINT EAST OF STRUCTURE
#3
#4
#5

AGE APROX 35 YEARS ACCORDING TO RESIDENTS: ROCKS PROBABLY
ADDED TO EAST SIDE OF GROIN LATER TO STOP EROSION.

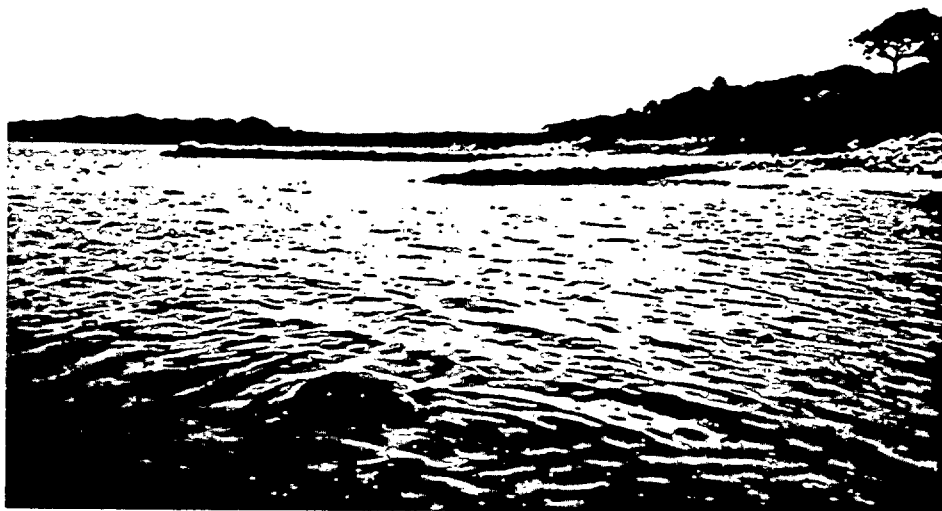
WH 3.00 #1

APROX. L= 240 FT, W= 20 FT

#1 ROLL 1 NEG 6 TAKEN FROM SOUTH SIDE
#2 ROLL 2 NEG 7 TAKEN FROM NORTH SIDE
#3
#4
#5

AGE APROX. 35 YEARS ACCORDING TO RESIDENTS; AREA LINED WITH
RANDOM BOULDERS AND SMALL GROINS LESS THAN 50 FT LONG.

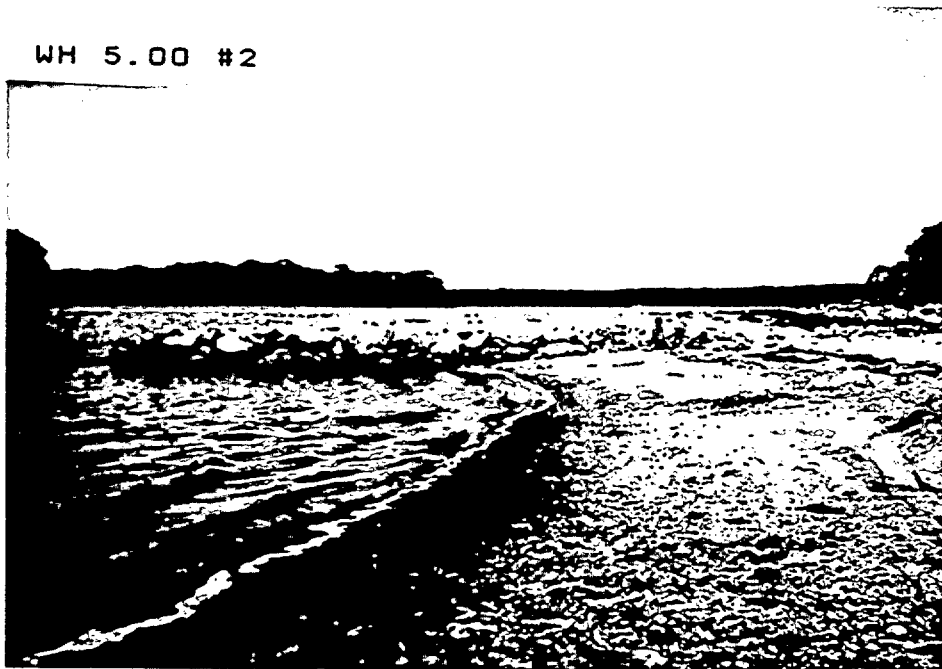
WH 5.00 #2

APROX. L= 85 FT, W= 20 FT

#1 ROLL 1 NEG 8 SEAWALL ON PROPERTY
#2 ROLL 1 NEG 9 GROIN FROM SOUTH SIDE
#3
#4
#5

GROIN MADE FROM ROCKS TAKEN FROM STRUTURE 4
